TECHNICAL REPORT GL-79-31

# UTILIZATION OF MARGINAL CONSTRUCTION MATERIALS FOR LOC

Geotechnical Laboratory

Final Report

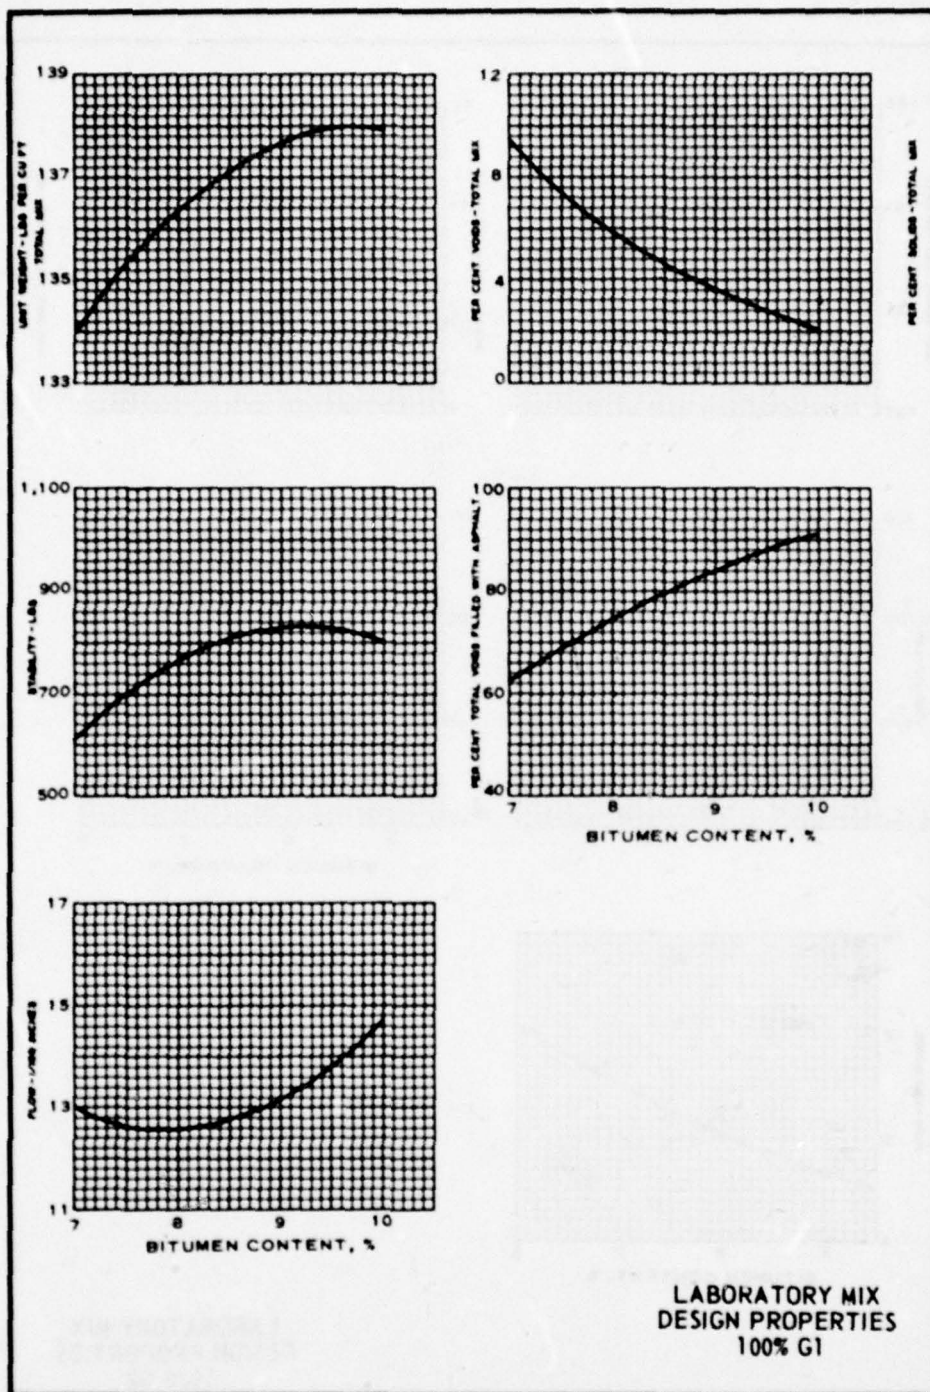
Figure 5. Laboratory mix design properties 100 percent G

28. The optimum asphalt contents as determined by the Marshall design criteria for the marginal materials appeared to be slightly high for the sand mixes. This is caused by the high percentage of voids in the mineral aggregates and the voids criteria used with the Marshall method of design. The voids criteria were developed for dense-graded high-quality aggregates, such as the crushed limestone (curve 1 of Figure 4), but do not appear to be applicable to poorly graded sands with little or no fines. Laboratory mix design properties for the marginal material mixes are shown in Figures 5-9. It was felt that the proper asphalt content should be just enough to coat the aggregate particles plus the asphalt that would be absorbed in the aggregate pores. The asphalt content required to provide the amount absorbed and a 6-micron film thickness based on the surface area of the aggregate was calculated for each mix. The asphalt content required by the film thickness method was computed by the following formula:

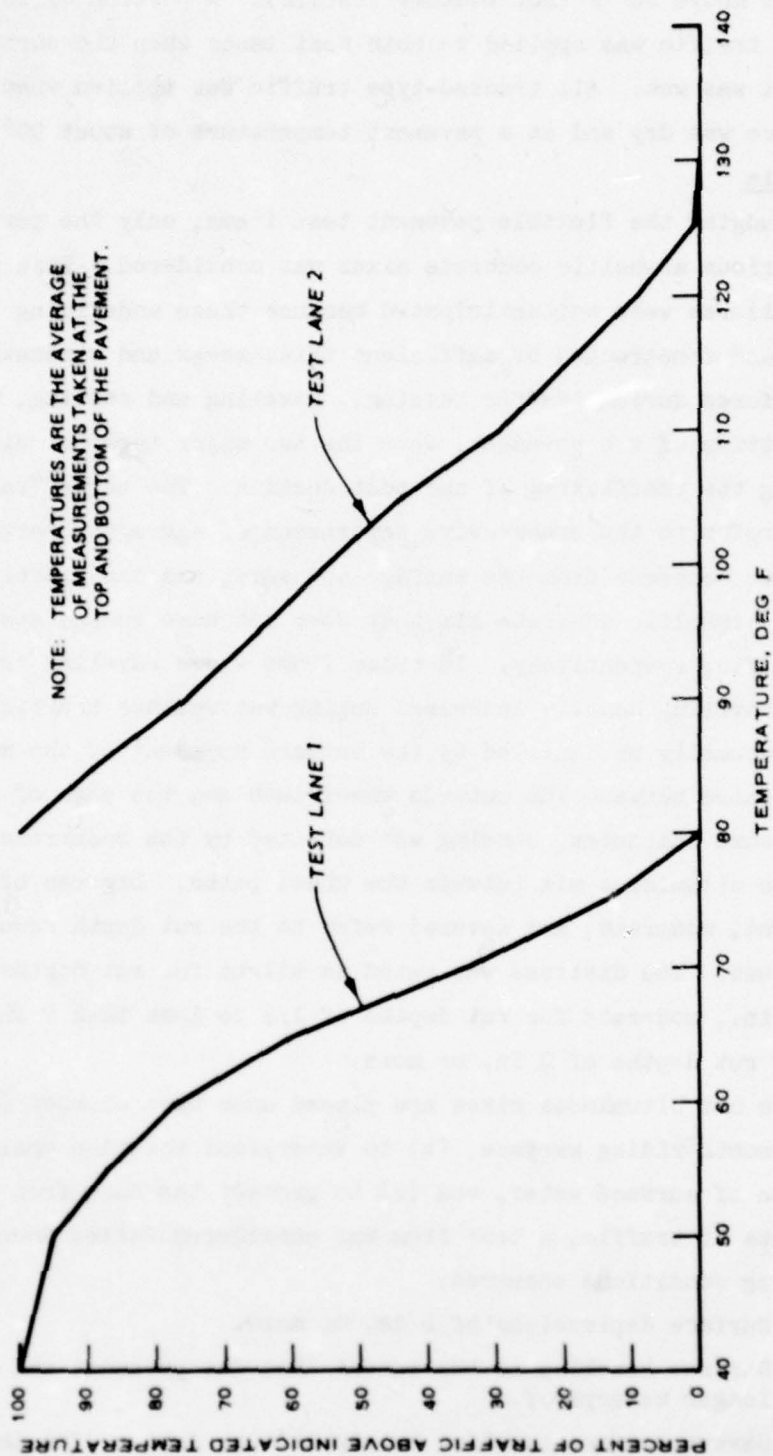
Figure 11. Traffic and pavement temperature - distribution curves for test lanes 1 and 2

54. Pneumatic-tired traffic was applied to the two traffic lanes of the test section during the period 22 September 1976-30 July 1977. During trafficking, the average pavement temperature, as determined from measurements at the surface and the bottom of the asphaltic concrete layer, ranged between 40° and 133° F. The traffic and pavement temperature-distribution curves for both test lanes (Figure 11) were derived from traffic and pavement temperature records made hourly during traffic testing. As noted in Figure 11, no traffic was applied to lane 1 (cold weather traffic) when the pavement temperature was 80° F or greater. To compare the behavior of the marginal material bituminous mixes under the same type of traffic but at a higher pavement temperature, traffic was applied to lane 2 when the pavement

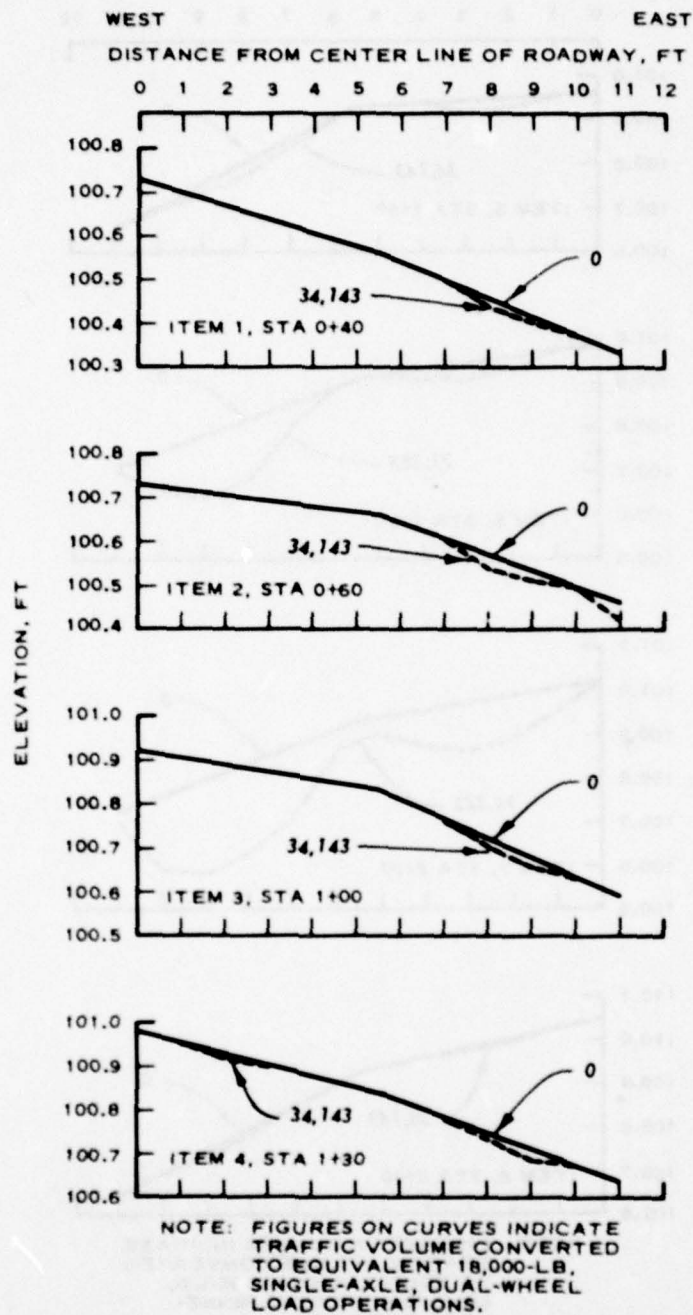
Figure 12. Typical cross sections of items 1-4, lane 1

68. Permanent pavement deformation. Level readings were taken across the test lanes at predetermined stations prior to and at failure or the end of traffic in each item. These observations were made to determine the magnitude of pavement deformation resulting from traffic. Typical cross sections for the 13 test items are shown in Figures 12-15. These data indicate that rutting occurred in the outside wheel path of all items and in the inside wheel path of all items except 1, 2, 3, and 9. These data also indicate that rutting was more pronounced in the outside wheel path.

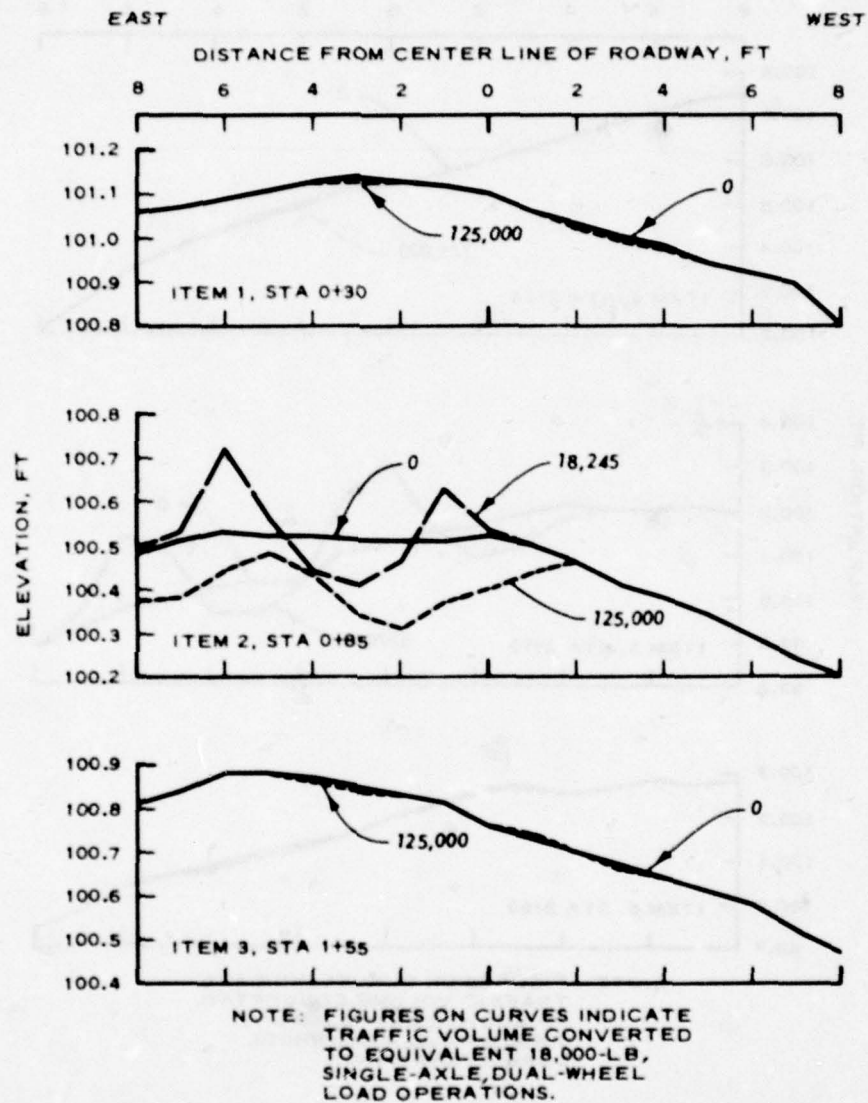
Figure 20. Typical cross sections of items 1-3, zero slump

91. Permanent pavement deformation. Level readings were taken in each item prior to traffic and at either failure or after traffic across the traffic lane at predetermined stations. The observations were made to determine the magnitude of pavement deformation resulting from traffic. Typical cross sections plotted for each item are shown in Figures 20 and 21.

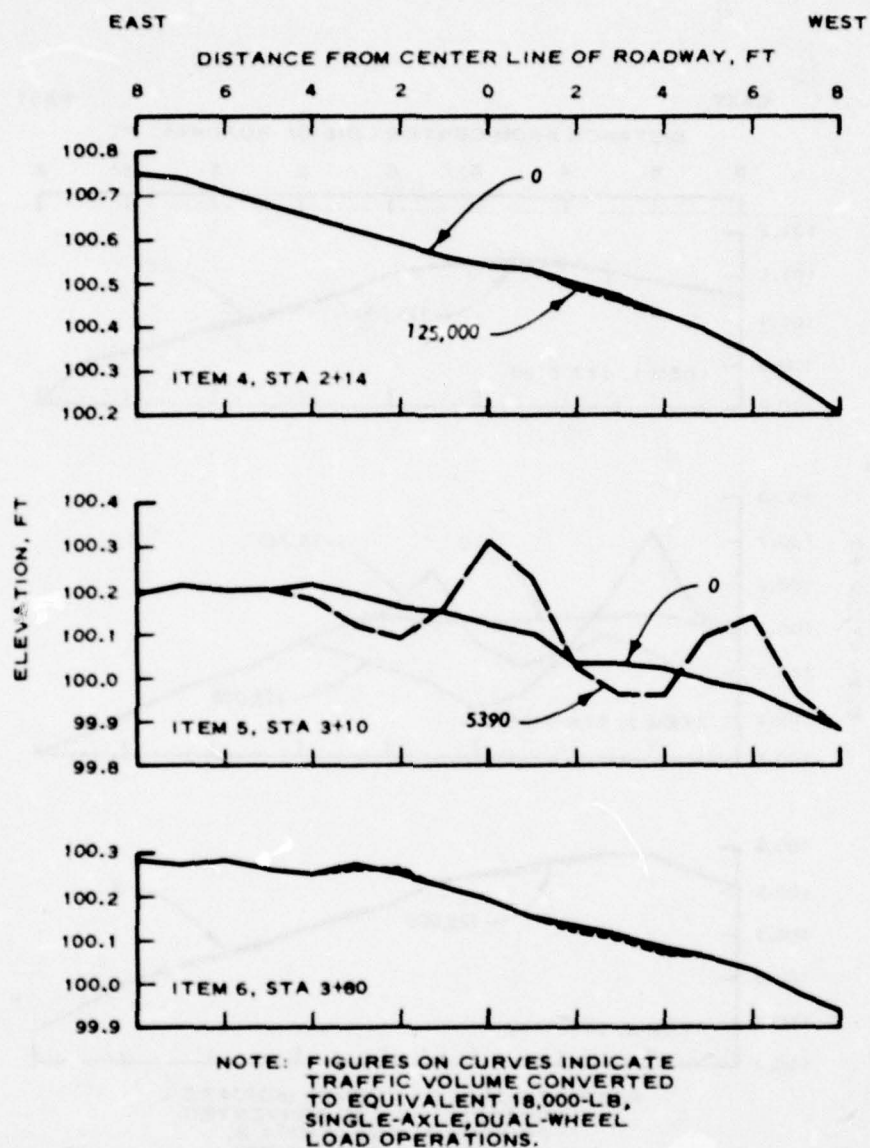
Figure 21. Typical cross sections of items 4-6, zero slump

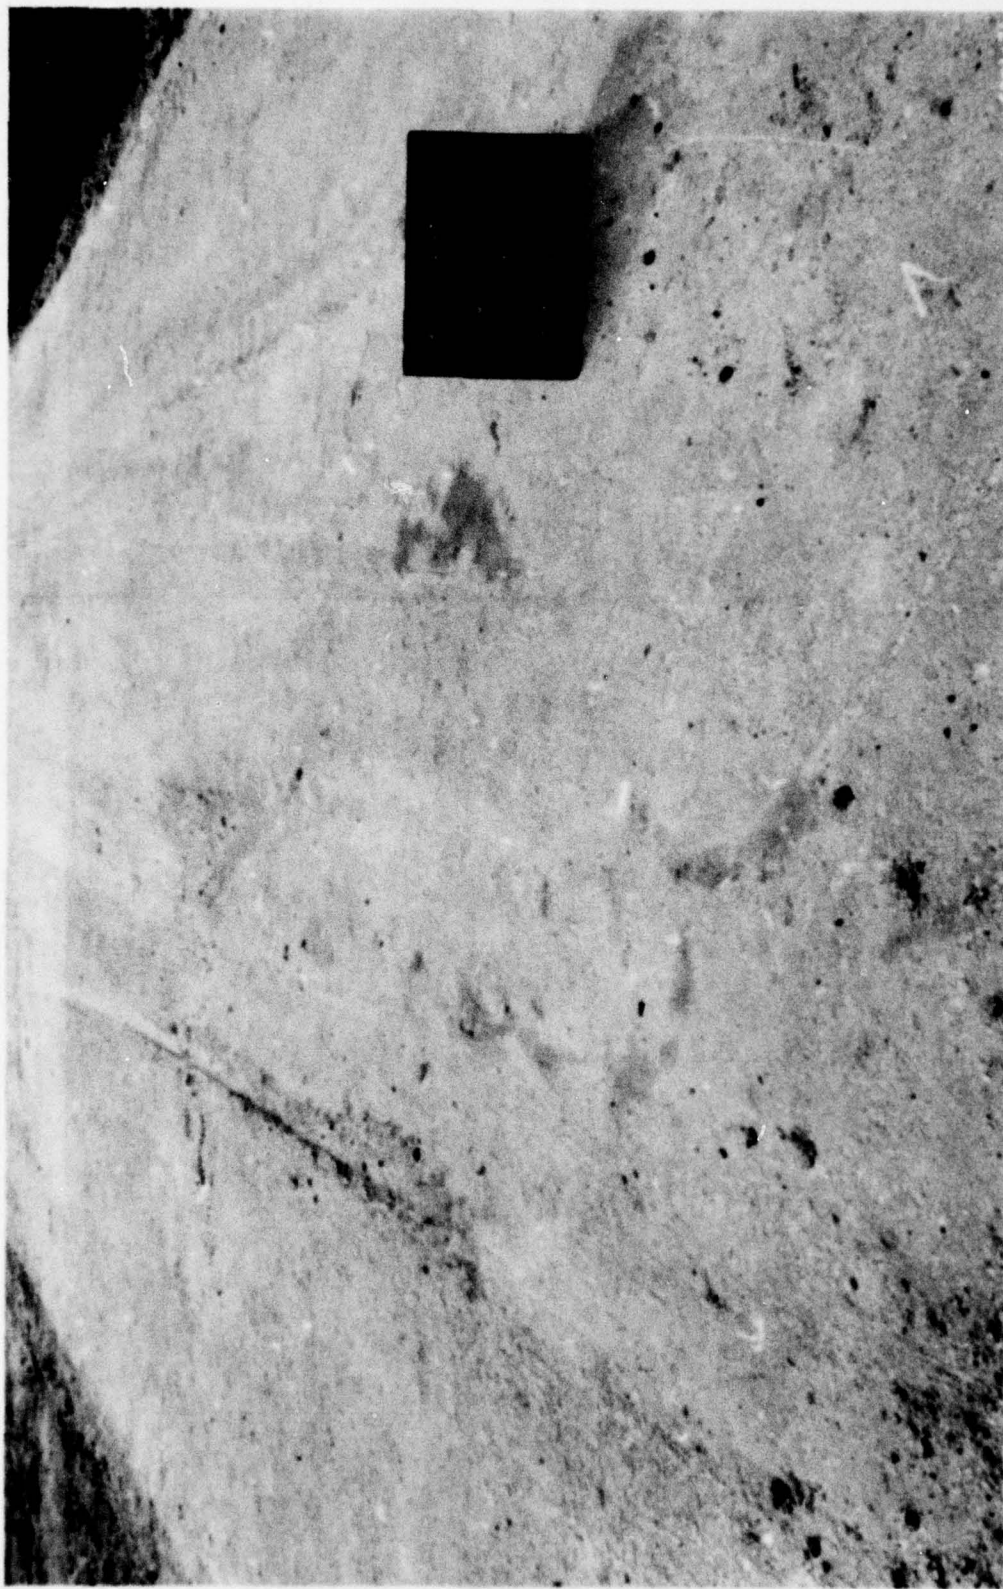
Photo 7. General view of item 1 (rigid pavement) prior to traffic

85. Visual observations. A general view of item 1 prior to traffic is shown in Photo 7. As can be seen, the general appearance of the surface was rough due to roller marks during compaction. No shrinkage cracks had developed in the pavement during the curing period. At the beginning of traffic, flaking along the ridges left by the roller was evident; however, after several passes of the test vehicle, very little progression of flaking was observed for the remainder of traffic. After 375 operations, raveling was detected in the east wheel path. This raveling began at the juncture of items 1 and 2 and extended into item 1 about 7 ft. Random cracking was noticed at the transition of items 1 and 2 after about 15,000 operations and at the opposite end of item 1 after about 73,000 operations. Since random cracking appeared only in transition areas, they were not considered in judging the performance

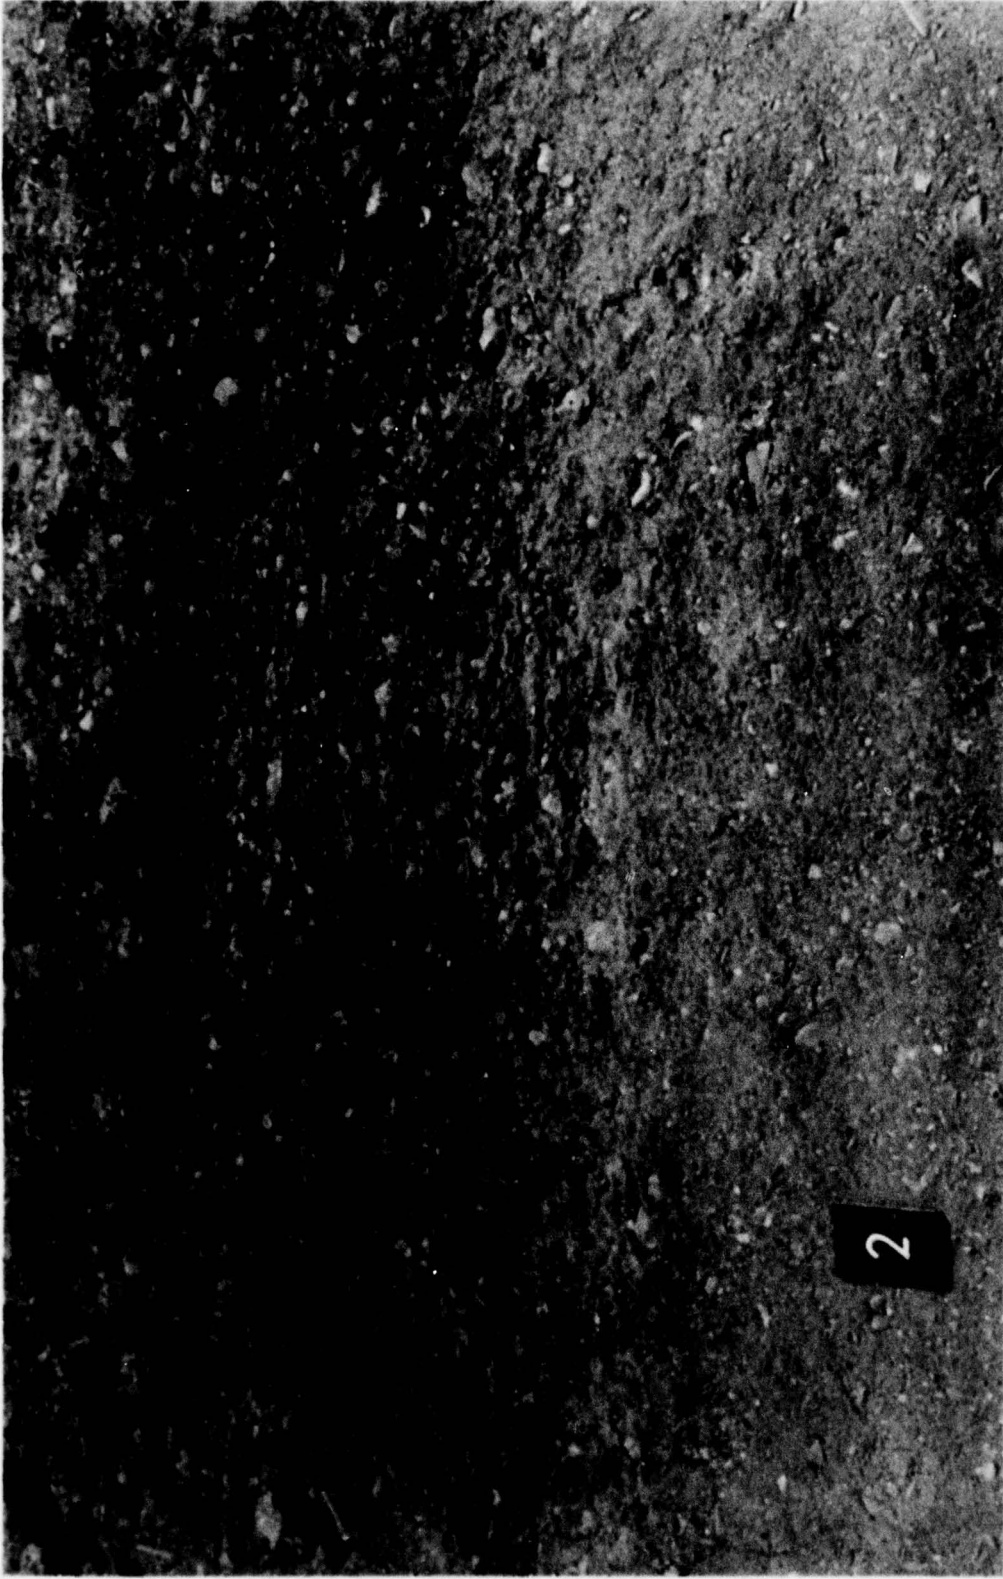
Photo 24. Shoving in item 2 after 8162 operations (outside wheel path)

8162 operations. A close-up of this distress, shoving of the asphaltic concrete in the outside wheel path, is shown in Photo 24. As traffic was continued, a slight rut developed in the outside wheel path due to this shoving. Except for the continued development of this rut, very little change in the condition of the pavement occurred to the end of traffic. Traffic was stopped after 34,143 operations, and this item was rated as in good condition. The maximum rut depth measured after traffic was 3/8 in. Photo 25 depicts the general condition of item 2 after traffic.

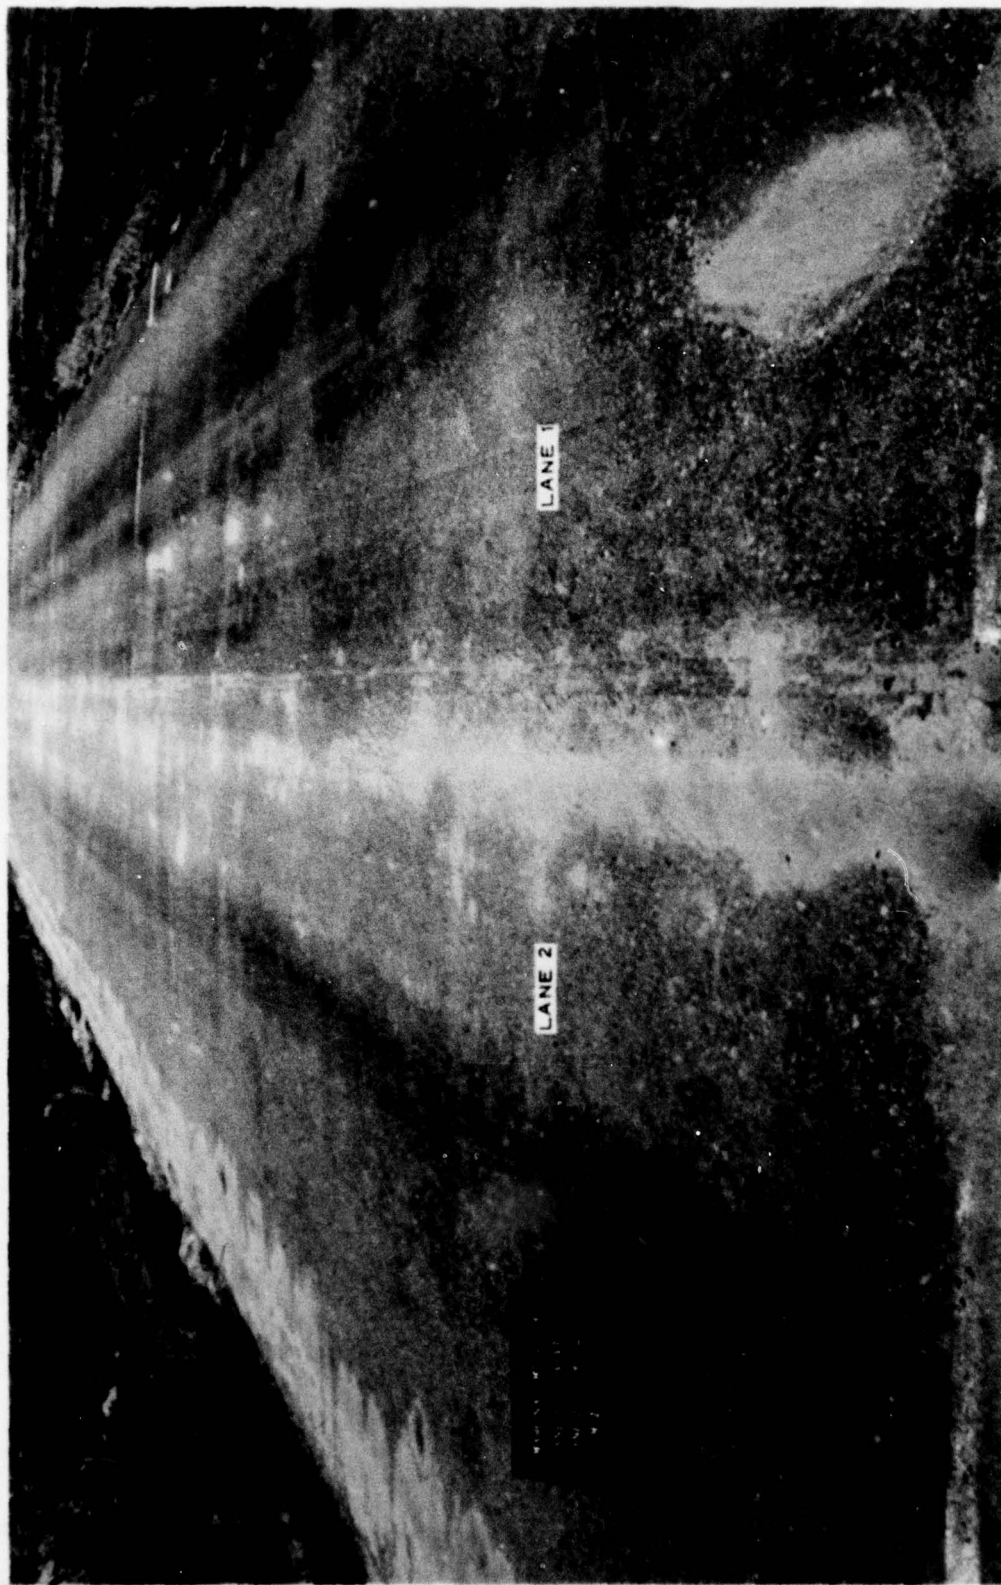
Photo 25. General view of item 2 after traffic (lane 1, 34,143 operations;  
lane 2, 106,752 operations)

71. Visual observations. Items 1-4 behaved similarly and quite well during traffic testing. Test items 1, 2, 3, and 4 of lane 2, prior to traffic, are shown in Photos 21, 23, 26, and 27, respectively. The first distress observed in any of these items was tire imprints plus slight shoving in item 2 after about 576 operations. The average pavement temperature at this time was about 95° F. Very little additional shoving was observed in item 2 throughout the remainder of the traffic period even though 60,000 to 70,000 operations were applied at pavement temperatures ranging between 95° and 133° F. After approximately 44,400 operations, 1/8-in.-deep ruts were measured in all four items. Exposure of the smooth surface of the larger aggregate was also observed in items 2-4 at this time. General views of the first four items after 44,400 operations are shown in Photos 57-60. The loose aggregate shown on the surfaces of these items is partially the result of raveling in items 5-7. During traffic testing, the tires of the test vehicle tended to pick up loose aggregate from the maneuver areas and the raveled material in items 5-7 and deposit the material over the entire test section. Traffic was continued to 106,752 operations, and at this time it appeared that all four items would carry test traffic indefinitely. Therefore, traffic was discontinued. At the end of traffic, 1/4-in.-deep ruts due to consolidation of the various asphaltic concrete mixes were measured in both wheel paths of the four test items. Exposure of the smooth and polished surfaces of the large aggregate was also observed in items 2-4 after traffic. Item 1 was rated in excellent condition, and items 2-4 were rated in satisfactory condition at the end of traffic. Overall views of items 1, 2, 3, and 4 after 106,752 operations are shown in Photos 22, 25, 28, and 29, respectively.

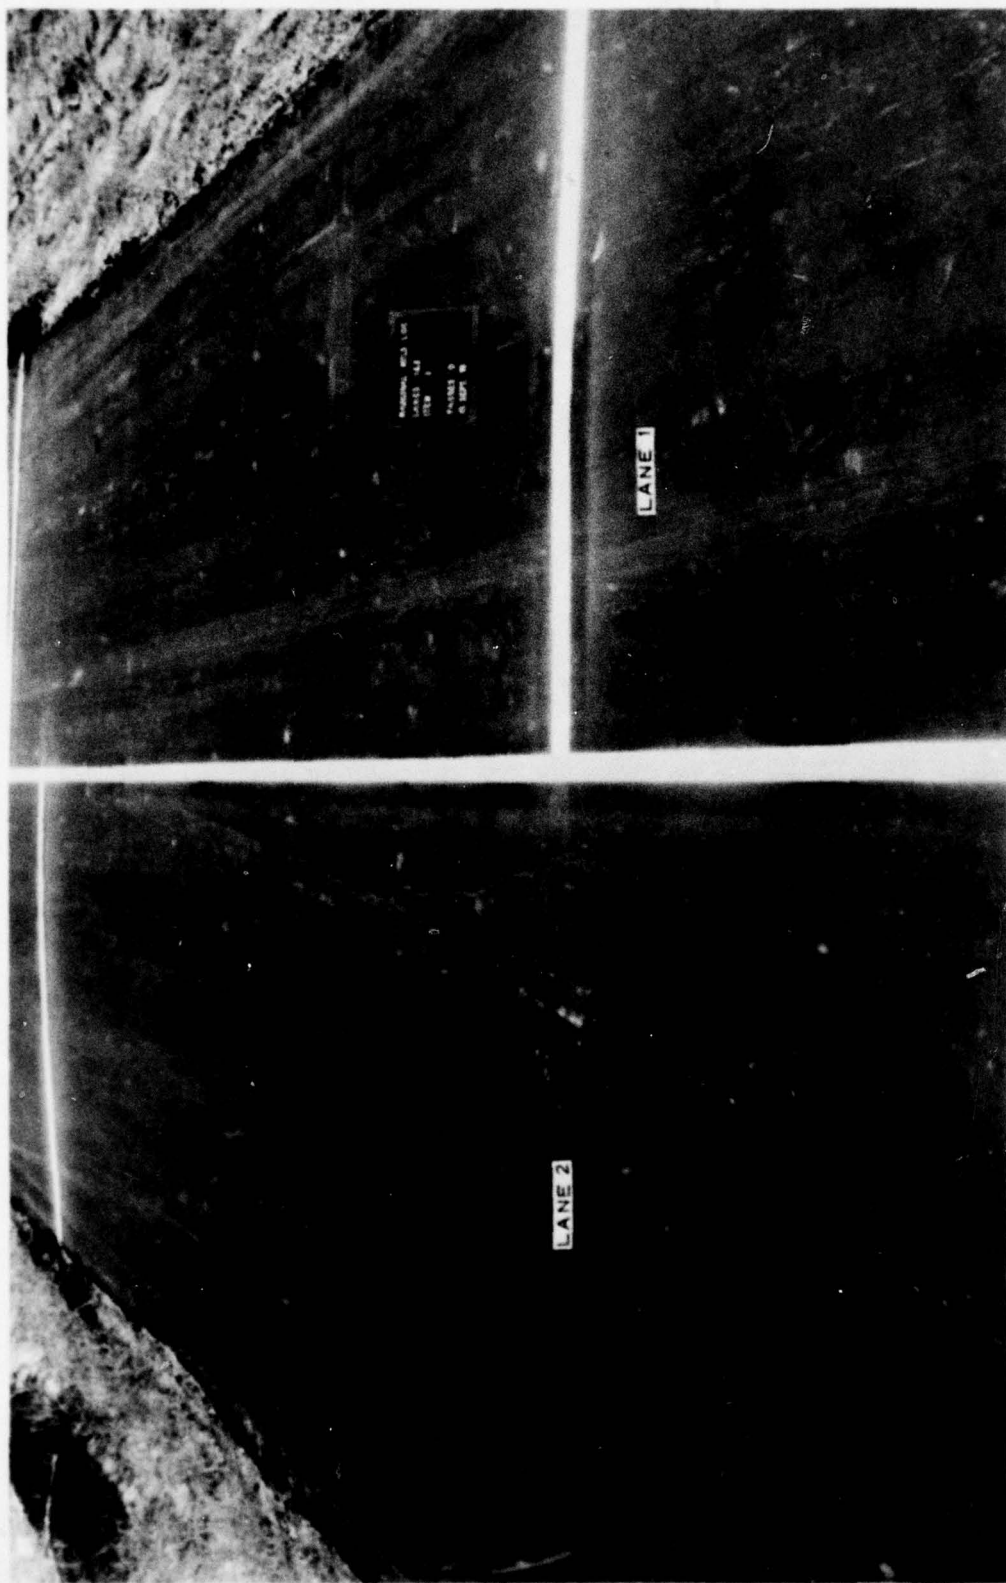
Photo 26. General view of item 3 (flexible pavement) prior to traffic

61. A general view of item 3 and item 4 before traffic is shown in Photos 26 and 27, respectively. Both of these items performed very well during traffic testing. The only pavement distress observed during trafficking of these two items was the raveling of the fine aggregate plus the exposure of smooth and polished large aggregate on the surface. After 34,143 operations, traffic was discontinued, and both items were rated as in good condition. General views of these items after traffic are shown in Photos 28 and 29.

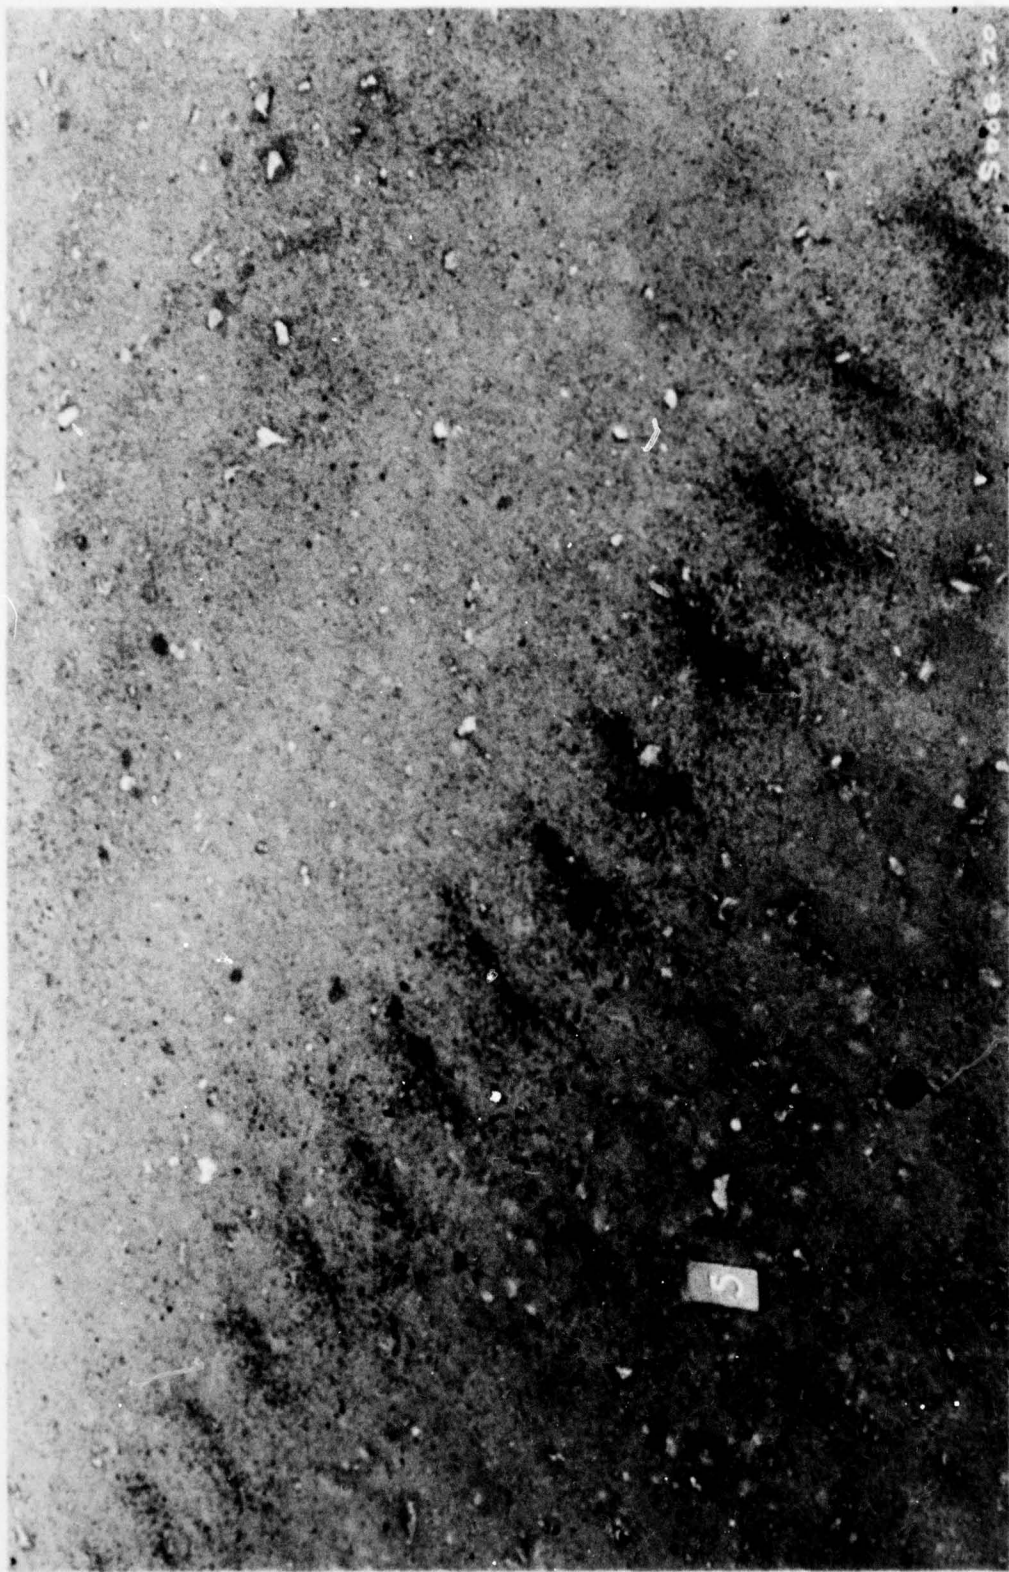
Photo 31. Raveling in item 5 after 1450 operations

62. An overall view of item 5 prior to traffic is shown in Photo 30. Raveling that resulted in rutting in the wheel paths was the only type of distress observed during traffic testing. Slight surface raveling of the fine aggregate was first detected after 6 operations. This raveling progressed very slowly during dry weather traffic. After about 1,450 operations, a few pieces of the larger aggregate had become dislodged (Photo 31). Smooth and polished large aggregate was also noticeable at this time. As traffic was continued, there was very little change in the performance of the pavement until traffic was applied during a rain. During wet weather traffic, the rate of raveling increased, and a slurry of water and dislodged aggregate particles formed in the wheel paths. However, after it rained and after the water evaporated, the rate of raveling decreased and many of the dislodged fine particles appeared to be recompacted in the wheel paths. Photos 32 and 33 depict a general view and close-up, respectively, of item 5 after 21,288 operations. Approximately 1,000 of these 21,288 operations were applied to the pavement either when it was raining or

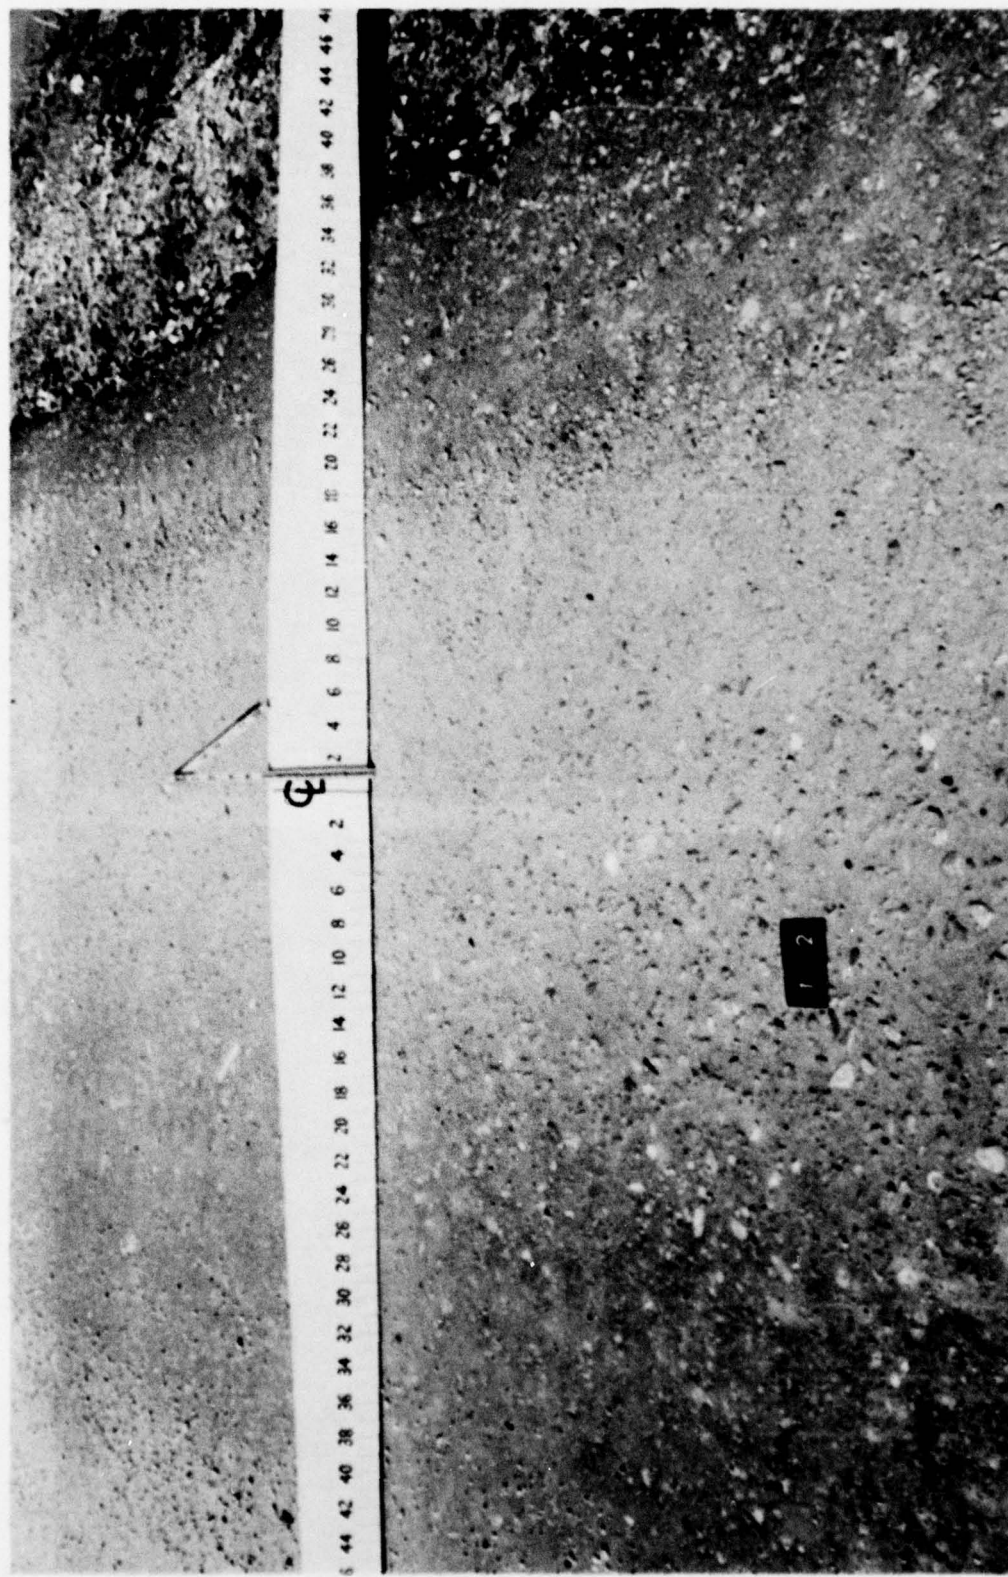
Photo 33. Close-up of 1/4-in.-deep rut in item 5 (outside wheel path) after 21,288 operations

when the pavement was wet. Photo 33 shows a rut about  $1/4$  in. in depth that developed in the outside wheel path after 21,288 operations. About 75 percent of this rut developed during the wet weather traffic. Throughout the remainder of traffic, the rate of raveling would increase during wet weather traffic and decrease during dry weather traffic. Test traffic was stopped after 34,143 operations, and the item was rated in poor condition due to raveling and rutting caused by raveling. The maximum rut depth measured after traffic in the inside wheel path was about  $1/4$  in., as compared with about 1 in. in the outside wheel path. As pointed out previously, the majority of the raveling occurred during wet weather traffic. Approximately 22 percent of the traffic applied in this item was done so on wet pavement.

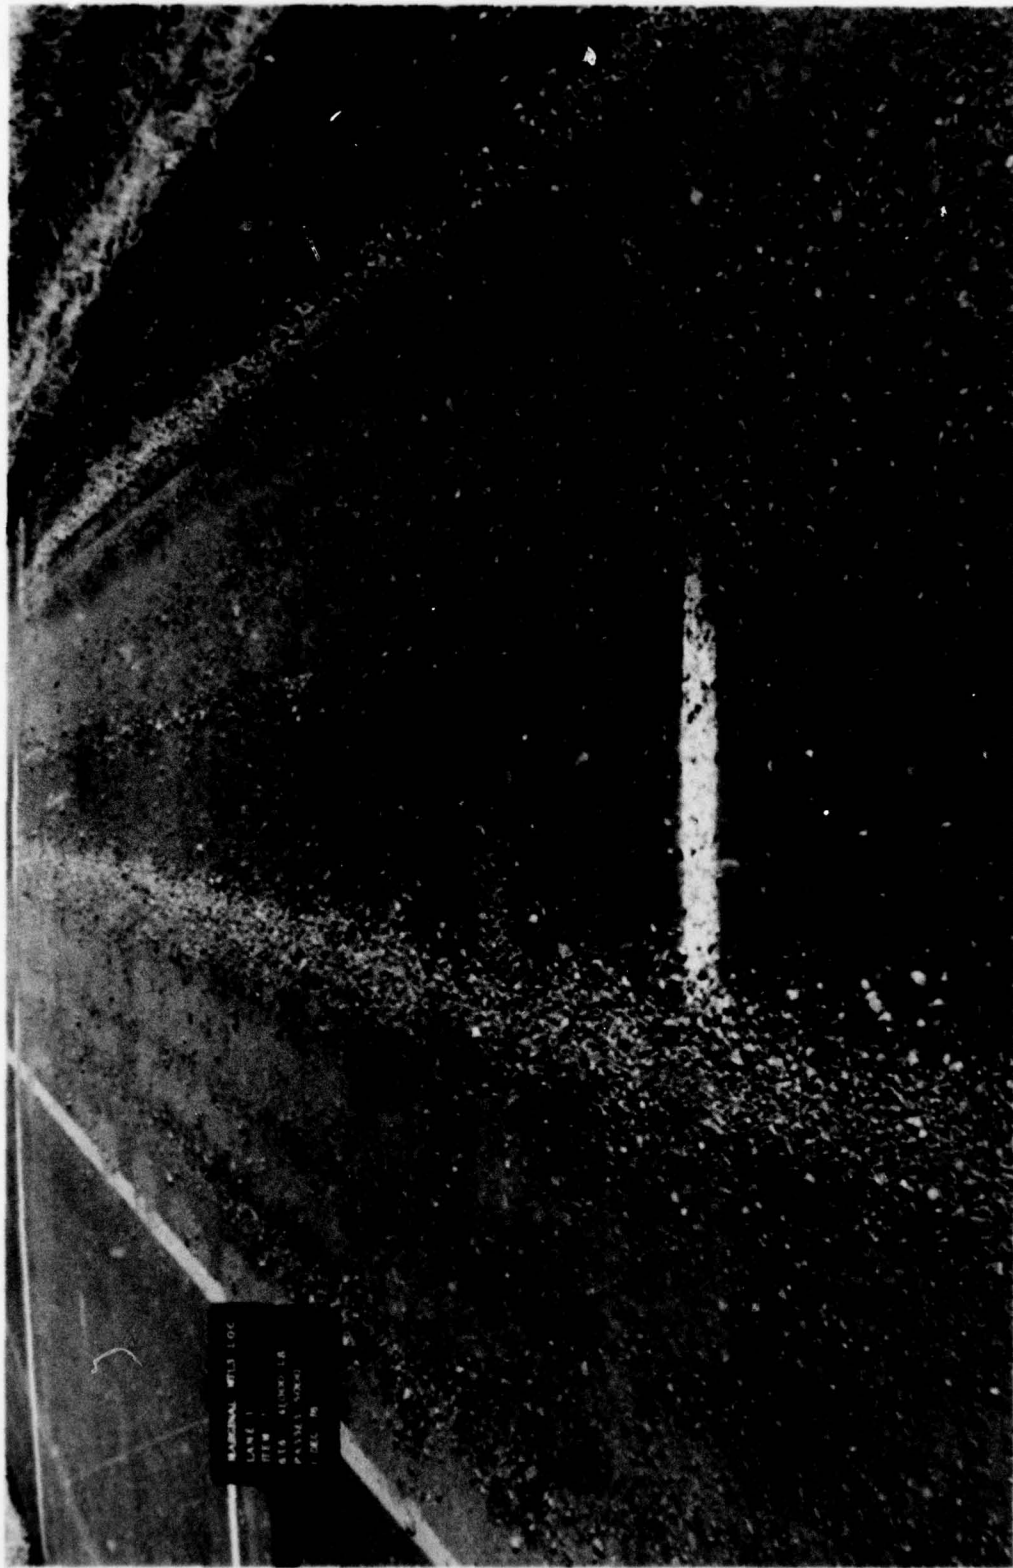
Photo 37. General view of item 7 after 14,323 operations (failure)

general view of item 7 after 14,323 operations (failure), and Photo 38 is a close-up of the 2-in.-deep rut in the outside wheel path at this time. Rut depths of 1-3/8 in. were measured in the inside wheel path of item 7 after 14,323 operations. Measurements in item 6 after 14,323 operations showed that the rut in the outside wheel path had increased in depth to 1-3/8 in.; therefore, traffic was continued. After a total of 21,288 operations (3,108 during wet weather), traffic was discontinued in item 6, and the item was rated failed because of severe raveling and rutting. A general view of item 6 after failure is shown in Photo 39. Photo 40 depicts the 2-in.-deep rut in the outside wheel path of item 6 at the end of traffic. The maximum rut depth measured in the inside wheel path of item 6 after 21,288 operations was 1/2 in.

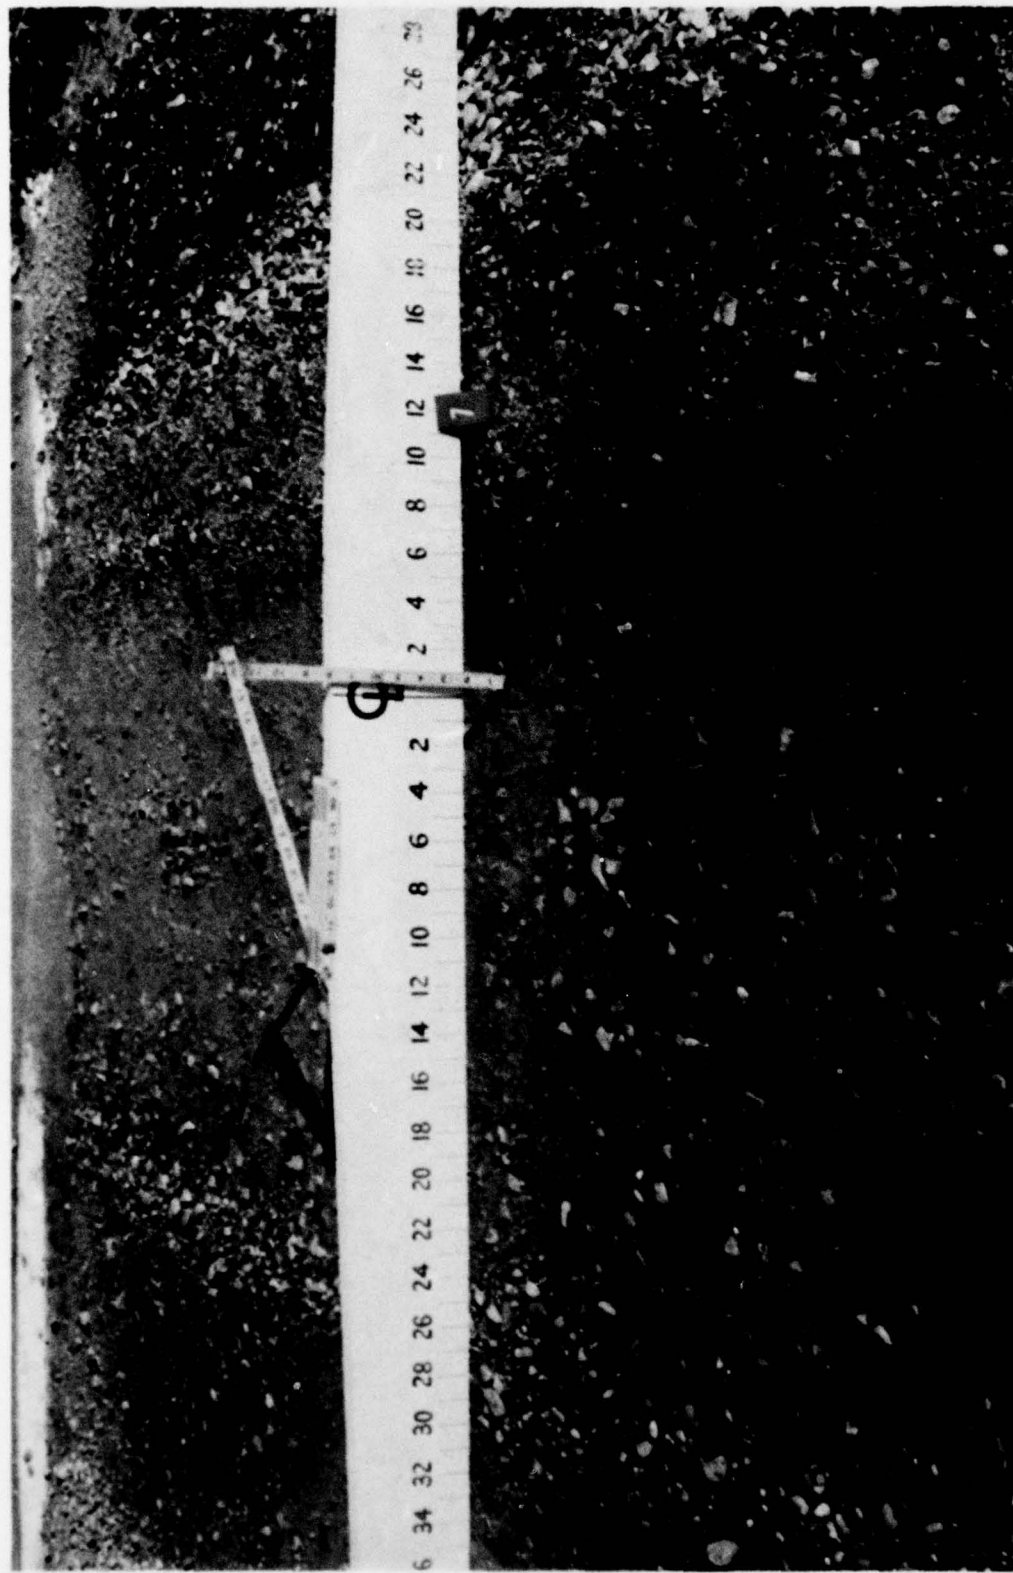
Photo 38. Close-up of 2-in.-deep rut in item 7 (outside wheel path)  
after 14,323 operations

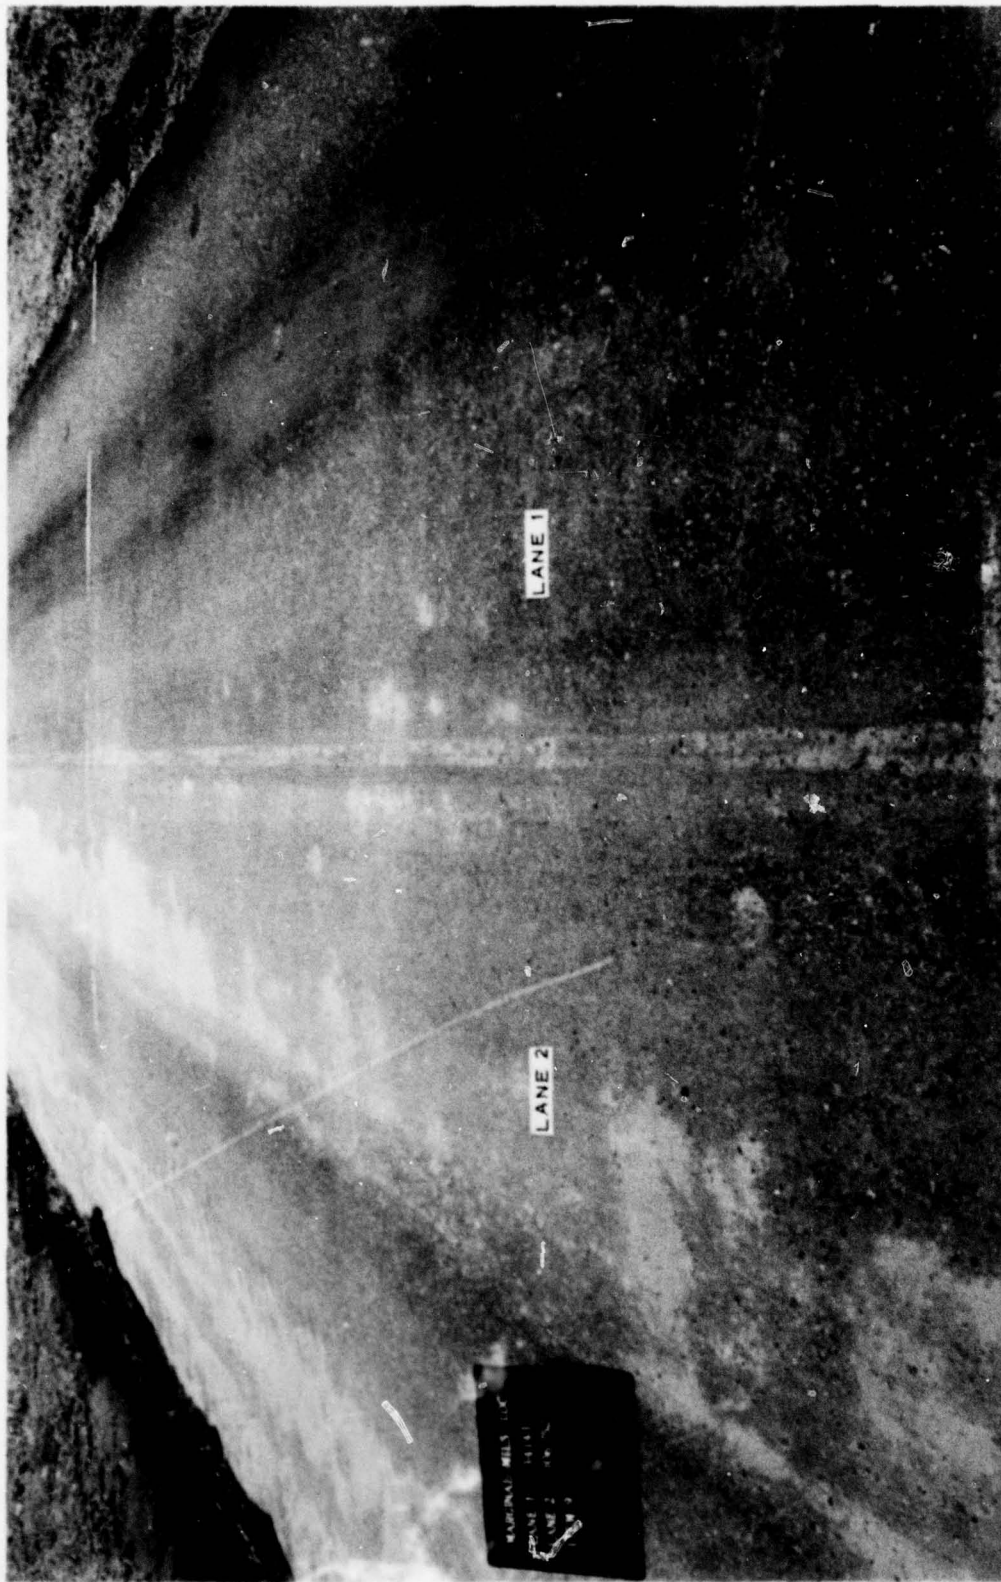
Photo 43. General view of item 9 after traffic (lane 1, 34,143 operations;  
lane 2, 106,752 operations)

64. The behavior of items 8 and 9 during traffic was essentially the same. Slight shoving of the bituminous mixes or tire imprints were observed in both items when traffic was applied during the hottest portion of the traffic period or when the average pavement temperature was about 80° F. A close-up of the outside wheel path in item 9 after 1,450 operations indicating tire imprints is shown in Photo 41. Slight polishing of the large aggregate was also observed in both items at this time. Traffic was continued to 34,143 operations in both items, with little or no change in the condition of the pavements. Indications were that a large number of operations would be required to produce any appreciable distress; therefore, traffic was discontinued. Views of items 8 and 9 at the end of traffic are shown in Photos 42 and 43, respectively.
